Stop that Leak

E-Beam Inspection Detects Crystal Defects Early in Device Fabrication

V. Mantovani, I.Mica, M.L. Polignano, L. Avaro, C. Pastore, G. Pavia – ST Microelectronics

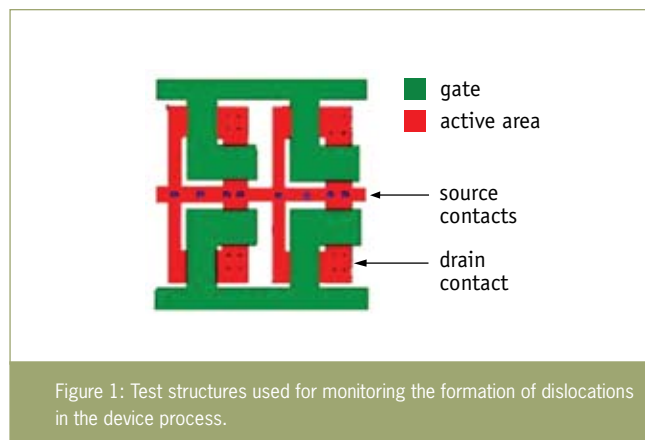
Structure description: Specific test structures for dislocation monitoring were designed to reproduce a critical pattern for dislocation formation and activation¹, consisting of transistor arrays with a high ratio (4:1) of active area corners to gates (figure 1). The rationale for this design is that the corner region of the active area pattern is the most critical in terms of mechanical stress: Two STI walls converge to an active

area corner region, and during oxidation the related stress fields superimpose in this region. Dislocations are most frequently observed close to the corners of the active area patterns², and structures with a high density of corners are prone to generating dislocations. The transistor array was designed with a common source region and individual drain regions, connected by parallel metal stripes as shown in figure 1.
